INSPECTION REPORT

INSPECTED BY
Keron Garraway
Garraway Property
Inspections

INSPECTION DATE
7/18/2021

Single Family (2 story)

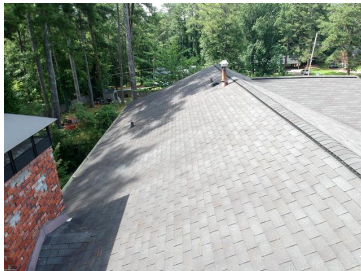
1.0 Item 1 (Picture)

The shingles have some sign of wear but no damage, missing shingles or gaps were found. The current shingle type have an estimated lifespan of 15-20, I recommend verifying with property owner to verify date of installation

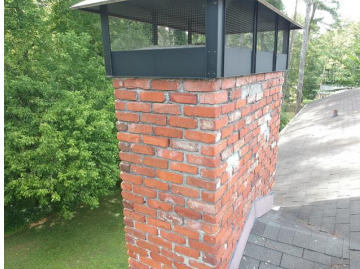
1.2 Item 1 (Picture)

No issues found at chimney.

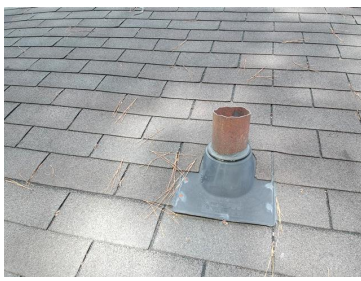
1.6 Item 1 (Picture)

Multiple vents have deteriorated seals around the exhaust pipe, lifting flashing and exposed nail heads. This conditions are conducive to roof leaks, I recommend a professional evaluate for repair or replacement.

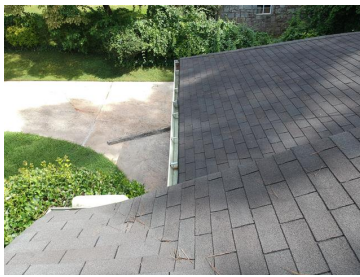
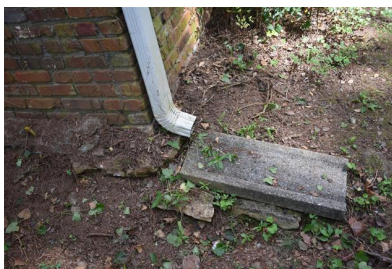
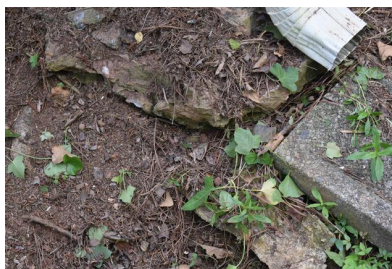
1.7 Item 1 (Picture)

- (1) The gutters were clear of debris during the inspection
- (2) The gutter at the back of the house needs a downspout extension, due to the erosion that has happened the gutter will allow water to terminate near the foundation.

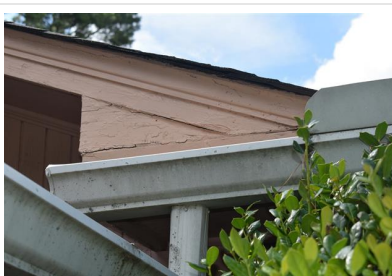
1.8 Item 1 (Picture)

There is some wood rot and/or water damage to some sections of the fascia board over the garage. I recommend having a professional repair or replace as needed.

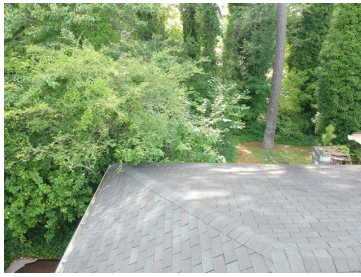
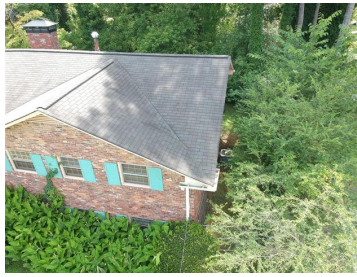
1.9 Item 1 (Picture)

There are overgrown trees around the property that need to be trimmed back to avoid damage to the roof and prevent vermin from gaining access to the attic space. I recommend having a professional trim as needed.

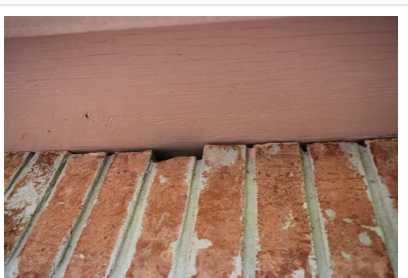
2.0 Item 1 (Picture)

There are multiple gaps along the wall of the garage/carport.

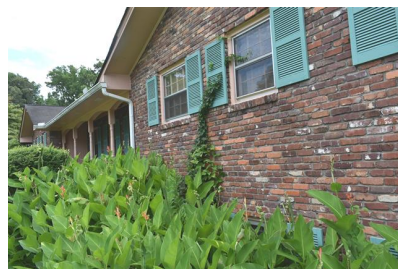
2.4 Item 6 (Picture)

The trees and shrubs are in contact with the house, this is condition conducive to moisture intrusion and wood destroying organisms. I recommend having all trees and shrubs trimmed back at least 6ft from exterior walls

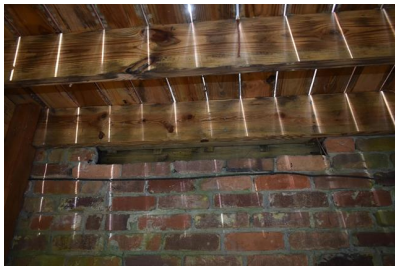
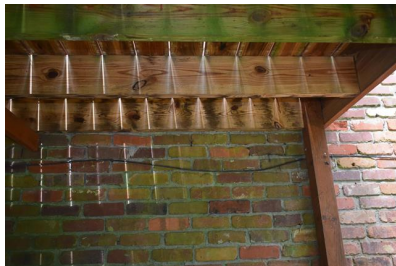
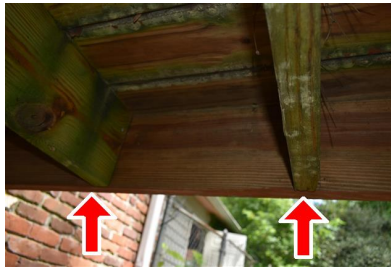
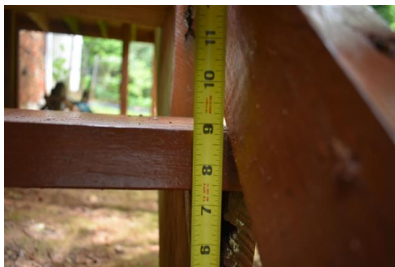
2.5 Item 1 (Picture)

(1) There are no lag bolts securing the deck to the ledger board, they are nailed in, this is safety issue

(2) There are no joist hangers under the floor joists, they have been attached with nails.

(3) One of the support posts have split approximately 3ft from the top, this is should be replaced for structural reasons.

(4) There are 3 risers that have wood rot

(5) The riser heights are too high, they are currently approximately 9 inches, the height maximum is 7 inches

I recommend having a professional evaluate for repair or replacement.

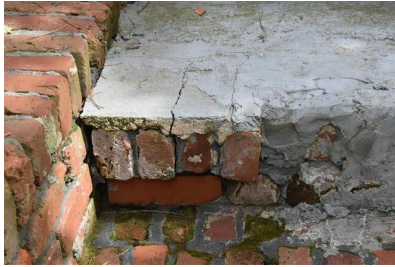
2.6 Item 1 (Picture)

(1) Multiple sections of the steps at the rear of the house are deteriorated and can pose a trip hazard if bricks become loose.

(2) One section is currently pulling away from the house

I recommend having a professional evaluate for repair or replacement.

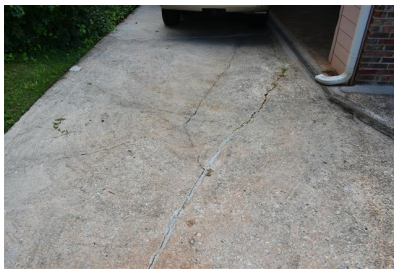
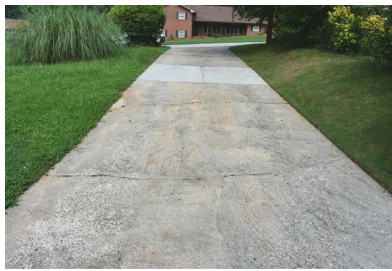
2.9 Item 1 (Picture)

No issues found in driveway, repairs may be made for cosmetic reason

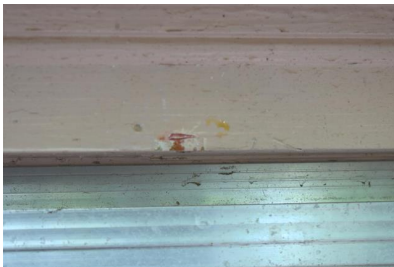
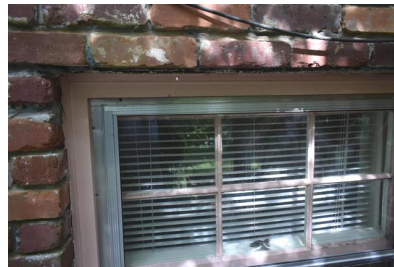
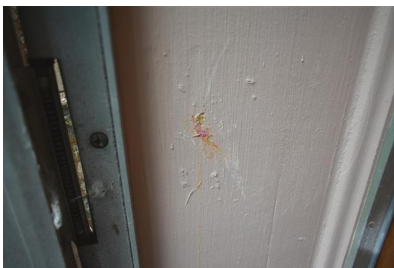
2.10 Item 1 (Picture)

Multiple sections of the exterior window frame and/or trim tested positive for lead based paint.

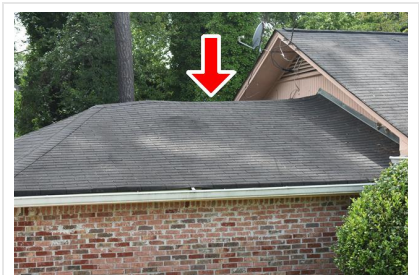
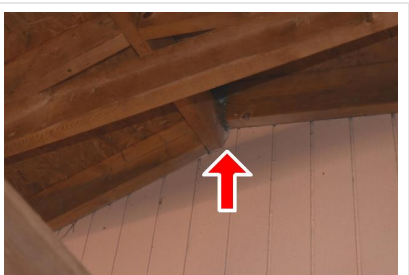
3.0 Item 1 (Picture)

- (1) There is a dip in the ceiling over the carport. On the underside the rafter beams are not evenly secured to the ridge beam. This is a substandard installation that will affect the roof's structural integrity as well as a condition conducive to roof leaks.
- (2) The ceiling on the interior where the original garage was has water stains in the ceiling, this is an indicator that it has been wet previously, I recommend having a professional roofer evaluate for repair or replacement.

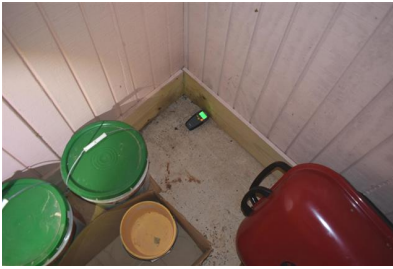
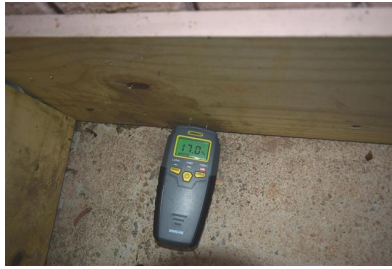
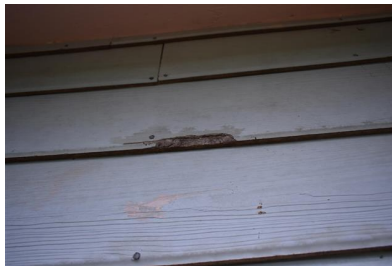
3.1 Item 1 (Picture)

- (1) The corner of the garage/carport is wet. I recommend having a professional evaluate for repair or replacement
- (2) The wall of the garage that faces the back of the house is deteriorated and may require replacing in some areas.

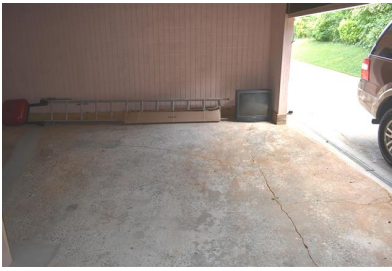
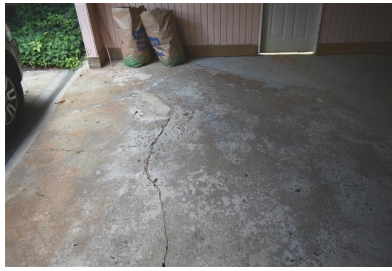
3.2 Item 1 (Picture)

There multiple settlement cracks in the carport/garage floor but no structural issues were found

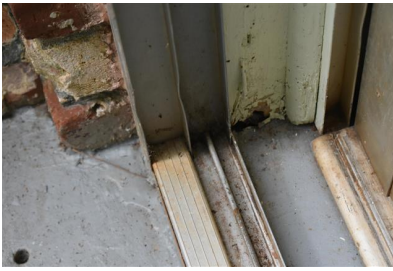
4.5 Item 1 (Picture)

The base of the sliding has wood rot on the left and right side

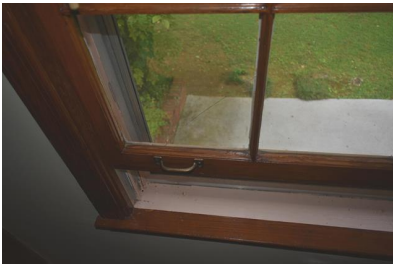
4.6 Item 1 (Picture)

- (1) One of the glass panes on the left of the fireplace is cracked.
- (2) Two glass panes of the basement window in the empty storage room is cracked
- (3) There was significant damage to the window in the living room. The window may need to be replaced.

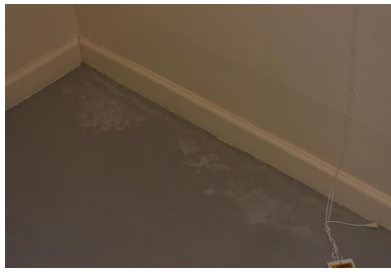
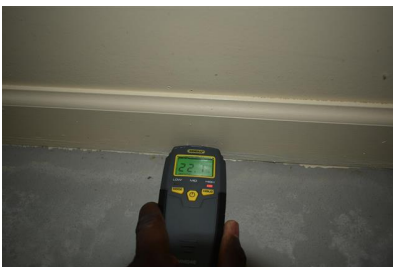
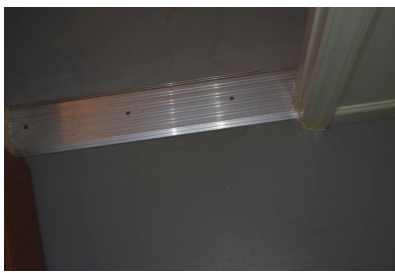
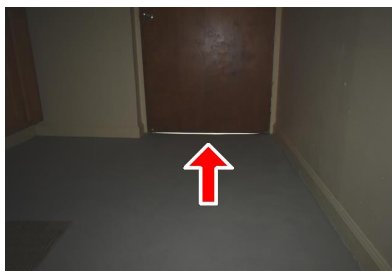
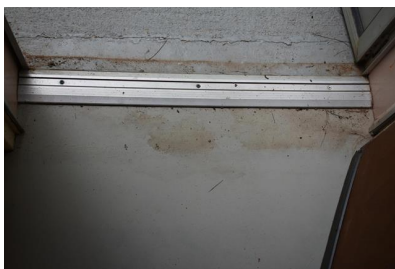
4.9 Item 2 (Picture)

The basement has evidence previous moisture intrusion.

(1) In the small storage room has stains on the floor and a mildew smell is preset

(2) The floor near the sink has water stains

(3) The wheatherstrip at the back door is not keeping water out due to the uneven floor, this will allow water to enter the basement during heavy rainfall

(4) The drywall near the furnace has water stains and minor fungal growth

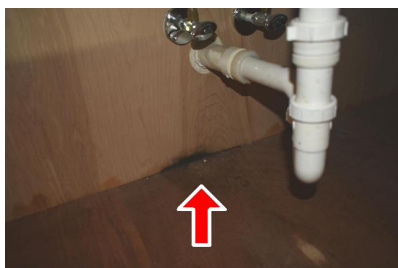
4.10 Item 1 (Picture)

There is some fungal growth under the sink but no active leaks were found.

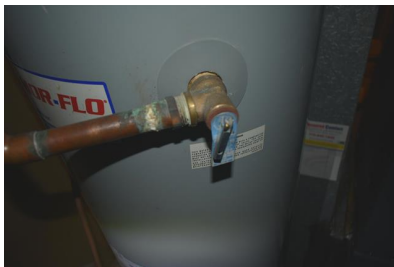
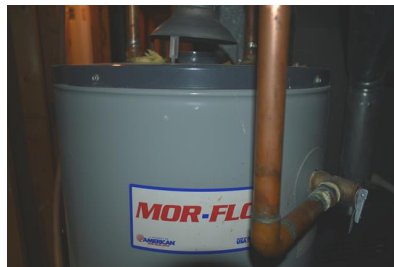
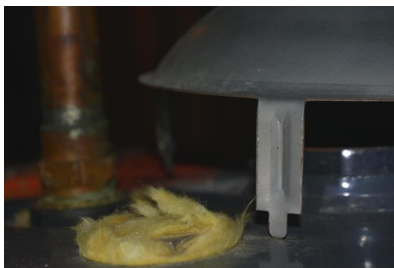
6.2 Item 1 (Picture)

(1) The pressure relief valve has seized up and will not trigger if it ever has to, this is safety hazard and I recommend having a professional replace.

(2) The water heater is 23 years old, the normal expected life expectancy of a water heater is 8-12 years. The water heater may require repairs or replacement soon.

(3) There is a small leak at the water heater shut off, I recommend replacing

(4) The vent hood is not properly secured to the water heater casing. There is only one screw holding it in place. I recommend having it properly secured to prevent potential back drafting to misalignment.

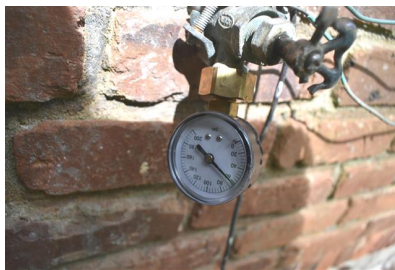
6.9 Item 1 (Picture)

Approximately 60 PSI

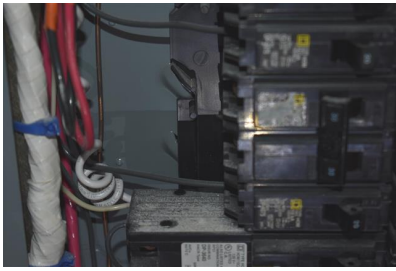
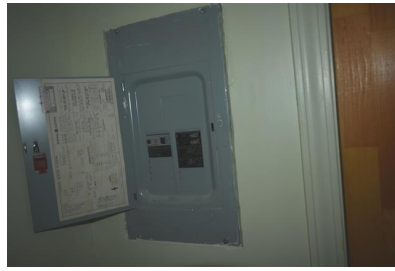
7.13 Item 1 (Picture)

- (1) The second to last breaker labeled "exhaust fan" is no wiring connected, no issues found.
- (2) No issues found in sub-panel in basement

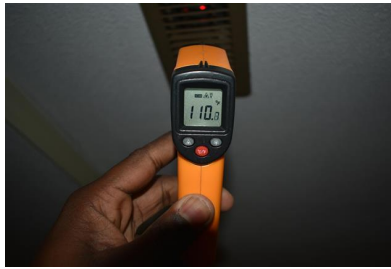
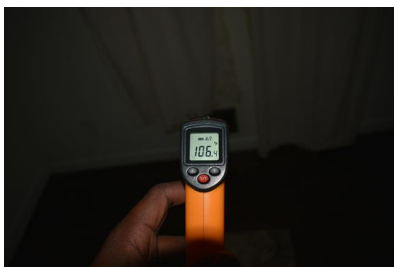
8.0 Item 2 (Picture)

The furnace is years old 17 years old, the estimated life expectancy of a furnace is 15–20 years. I recommend having the unit serviced by HVAC technician for evaluation.
The furnace cycled to heat without issues

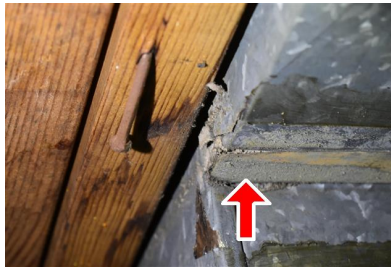
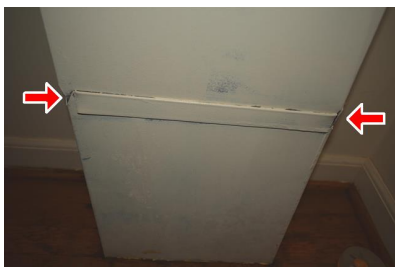
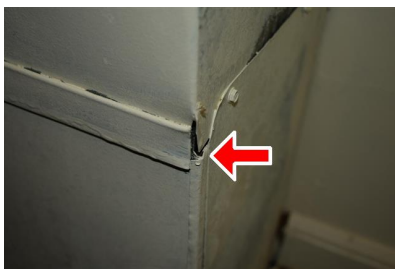
8.3 Item 2 (Picture)

(1) There is asbestos tape present around multiple sections of ductwork, some areas the tape is broken or deteriorated.

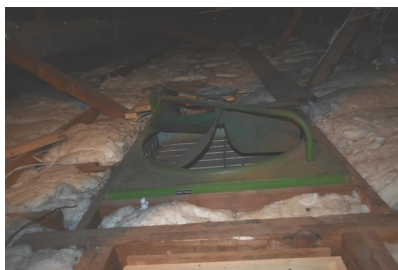
8.12 Item 1 (Picture)

There was a wholehouse fan present during the inspection. I recommend having professional evaluate for functionality if they plan on using.

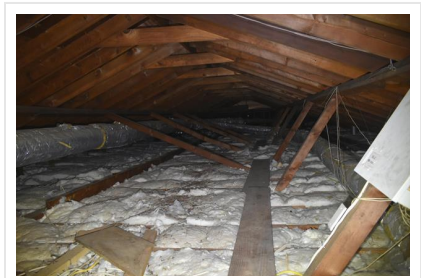
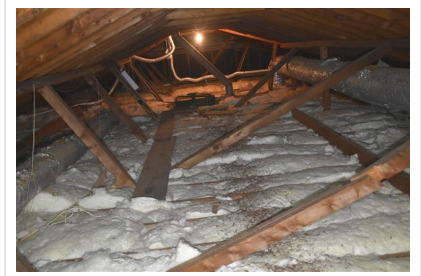
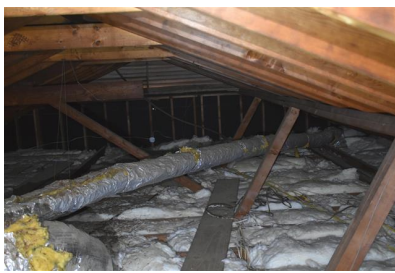
9.0 Item 1 (Picture)

The attic insulation was satisfactory

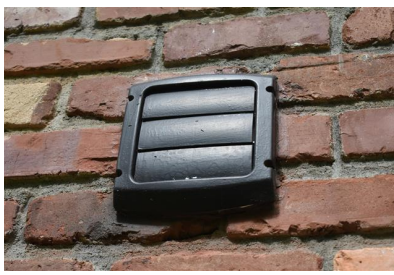
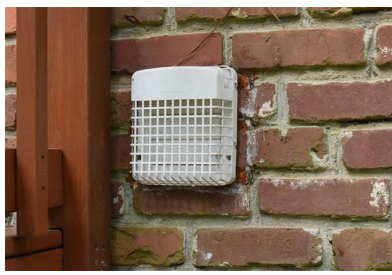
9.6 Item 1 (Picture)

The white dryer vent has a mesh type covering that can clog over time, this is potential fire hazard.

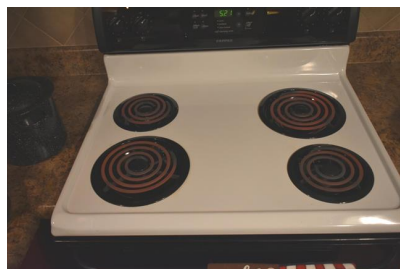
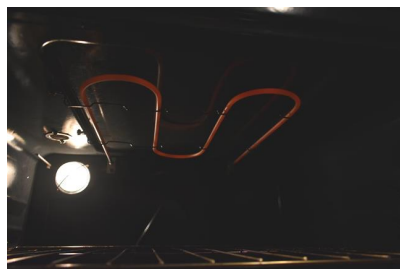
10.1 Item 1 (Picture)

No issues found at the range

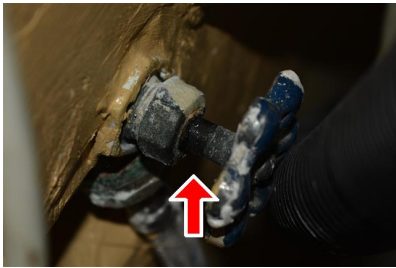
10.6 Item 1 (Picture)

One of the shut off valves is damaged and the second one has a small leak.
